TEST REPORT

3. Name of Product and Model : Network Camera /
XND-6010* (* N: NTSC / P: PAL)

6. Test method used : IEC 62262: 2002 (IK 08)

3.1 IK 08 Impacts Test

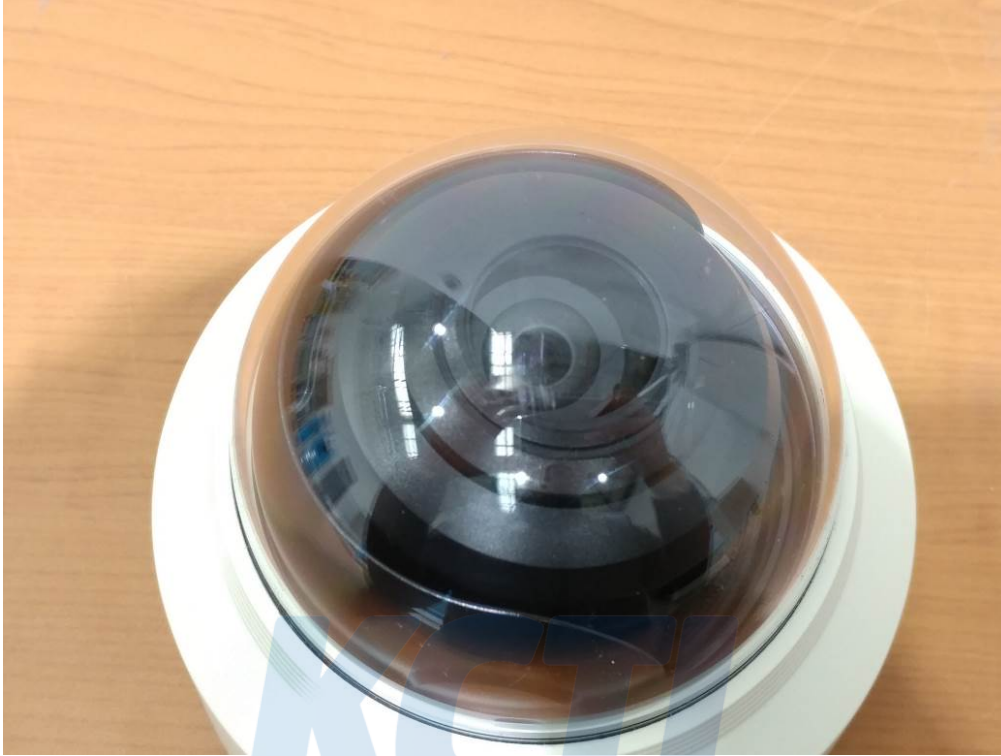
[Test result confirme_Window]

Check List	Test Result
<ol style="list-style-type: none">1. Window part<ul style="list-style-type: none">- Visual inspection after impact test (Damage, crack, separation occur)- Protected against access to hazardous parts2. Enclosure part<ul style="list-style-type: none">- Visual inspection after impact test (Damage, crack, separation occur)- Protected against access to hazardous parts	15mm crack occurrence (Refer to 3.1.7)
