# TEST REPORT

**3. Name of Product and Model** : Network Camera / XNO-8080R\*(\*N: NTSC / P: PAL)

**6. Test method used** : IEC 62262: 2002 (IK 10)

#### 3.1 IK10 Impacts Test

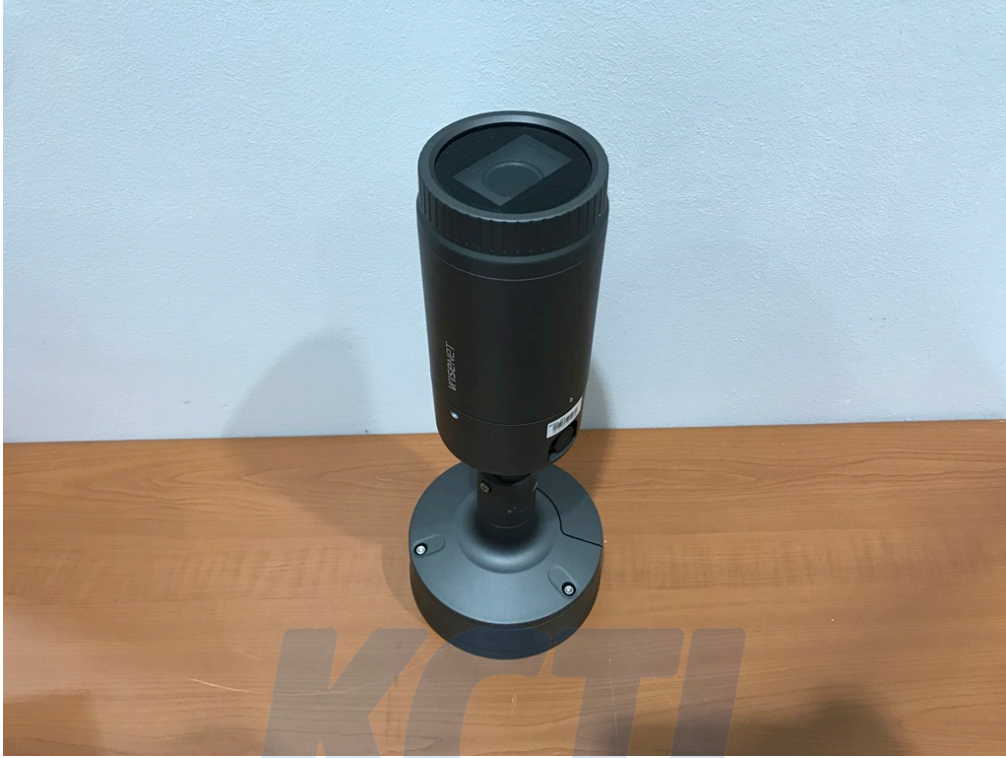
[Front]

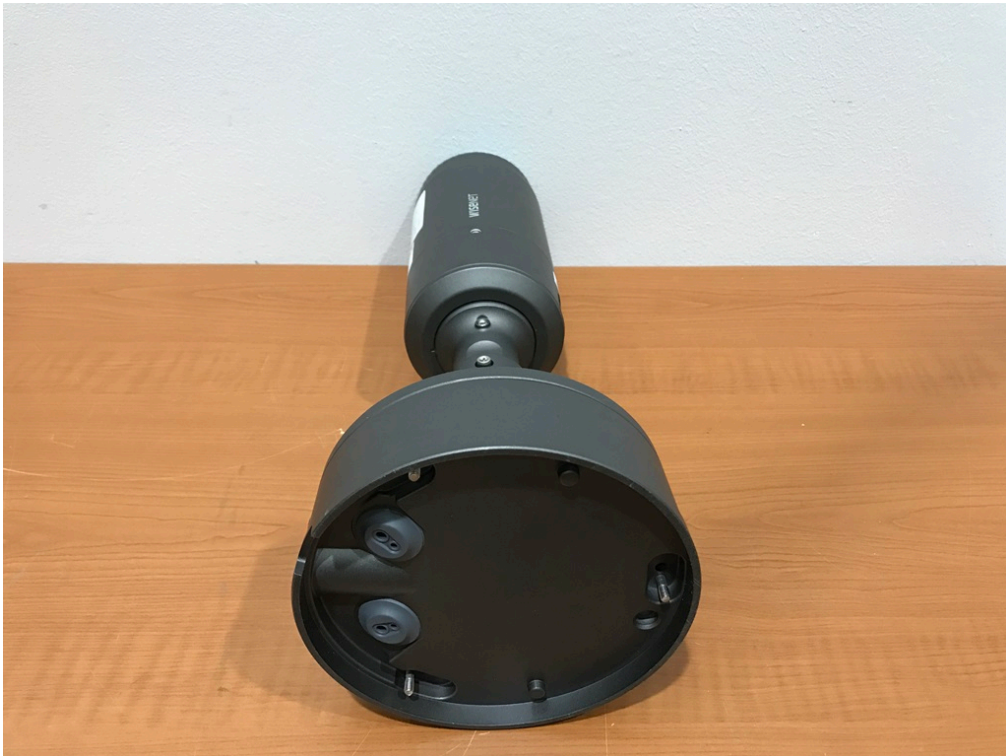
[Rear]

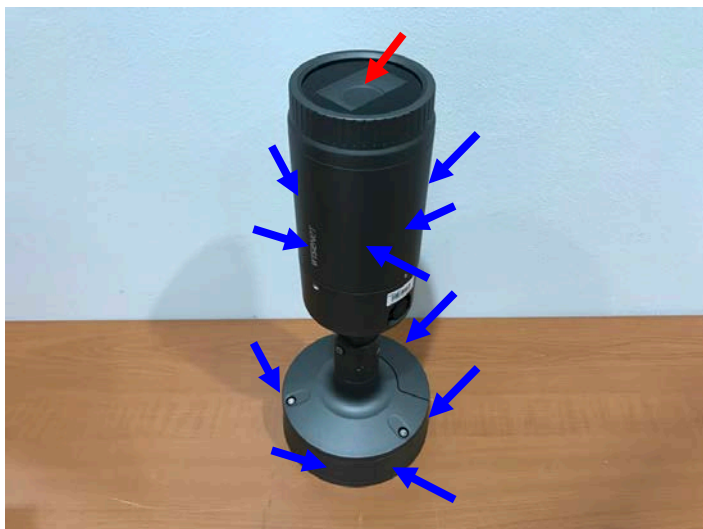
- 1) Test method used: IEC 62262: 2002 (IK 10)
- 2) Energy: 20 J
- 3) Mass: 5.0 kg
- 4) Height: 400 mm
- 5) Preprocessing: None
- 6) Location and number of impact: Window 1 impact, Enclosure 10 impacts

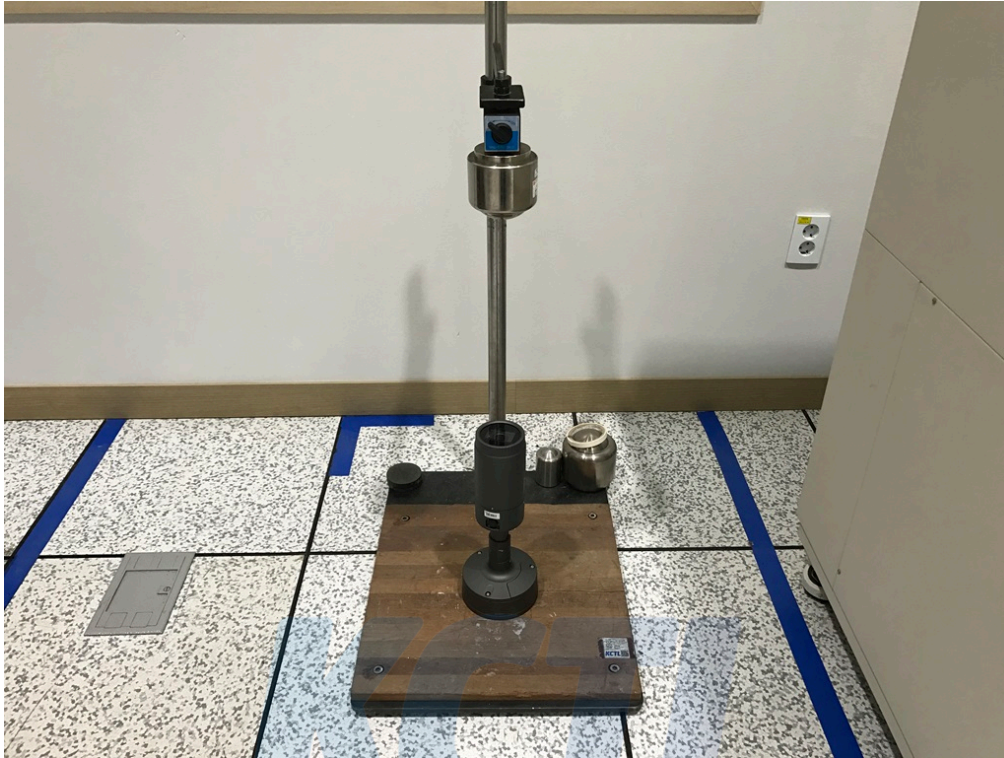
[During the test\_Window]

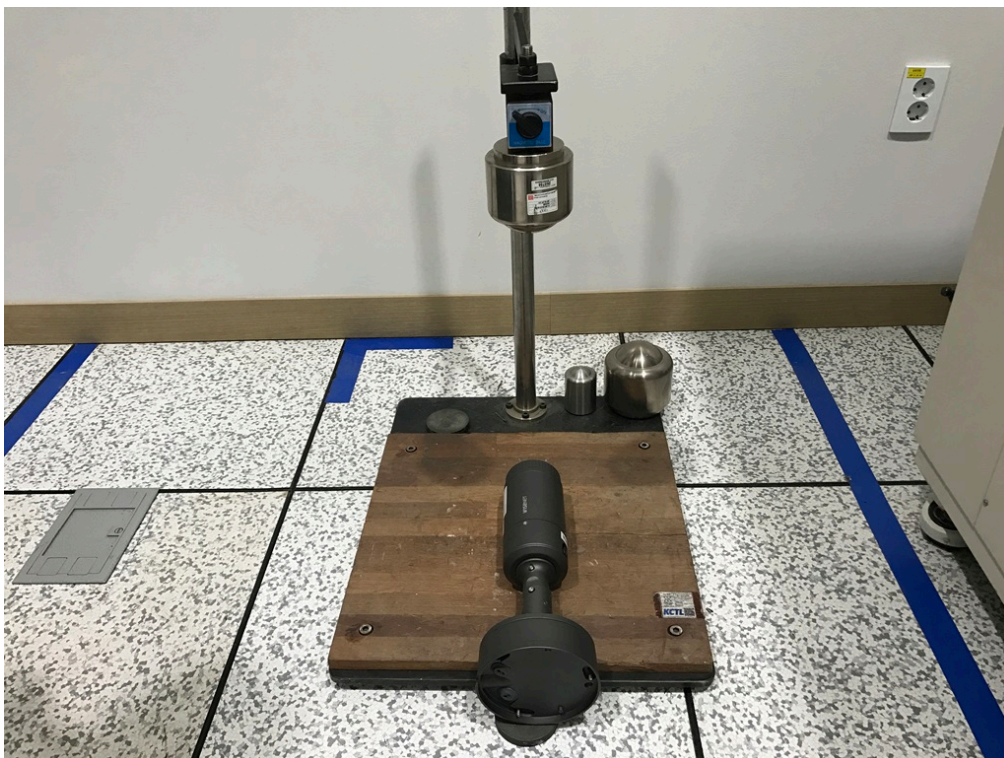
[During the test\_Enclosure 1]

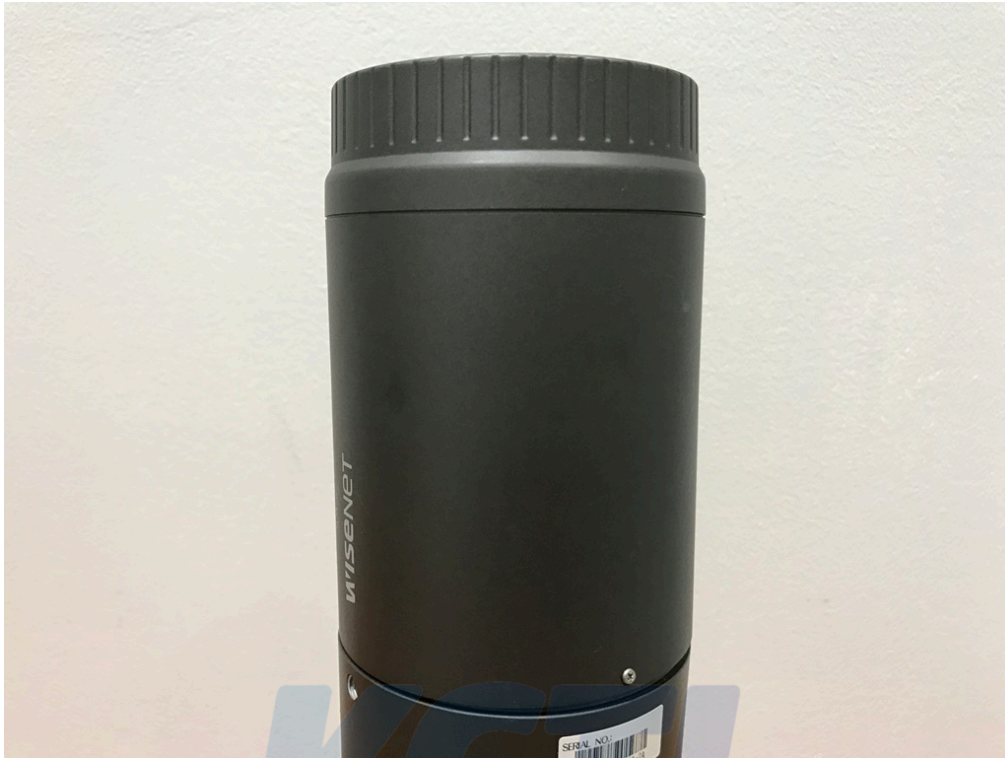
[Test result confirmation\_ Enclosure 01]

| Check List | Test Result |
|---|---|
| <ol style="list-style-type: none"> <li>1. Window part <ul style="list-style-type: none"> <li>- Visual inspection after impact test<br/>(Damage, crack, separation occur)</li> <li>- Protected against access to hazardous parts</li> </ul> </li> <li>2. Enclosure part <ul style="list-style-type: none"> <li>- Visual inspection after impact test<br/>(Damage, crack, separation occur)</li> <li>- Protected against access to hazardous parts</li> </ul> </li> </ol> | <p align="center">No abnormal<br/>was found<br/>(Refer to 3.1.7)</p> |

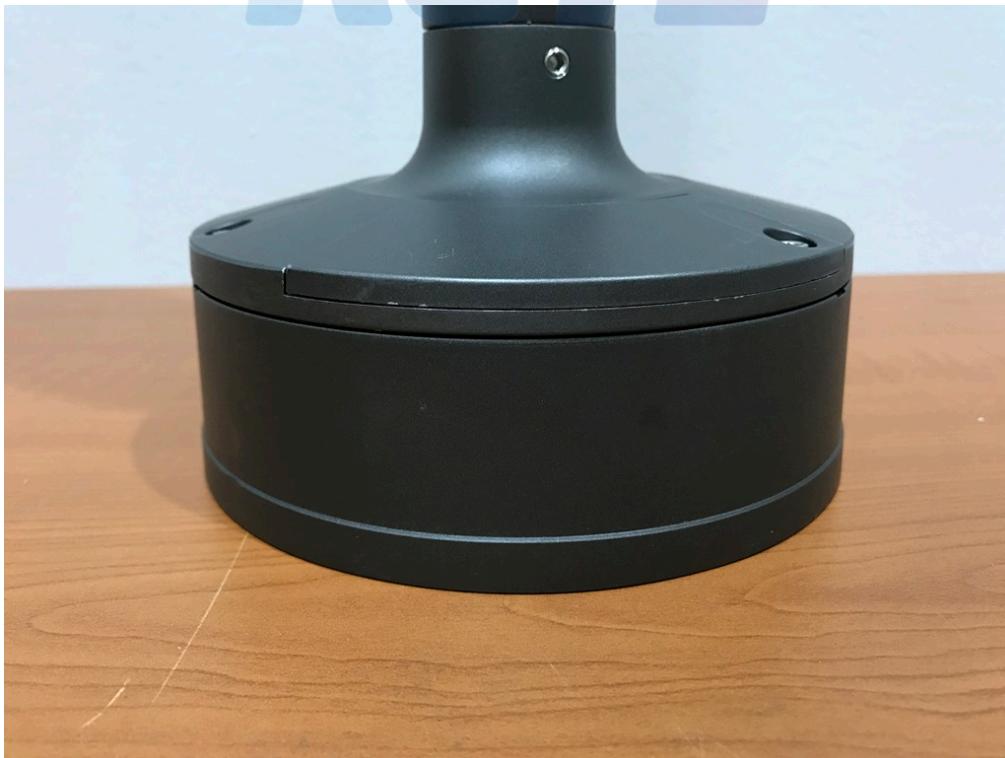
[Test result confirmation\_ Enclosure 02]
