# **TEST REPORT**

KCTL16-YRS0171

**Network Camera**

IEC 60529 / IP66

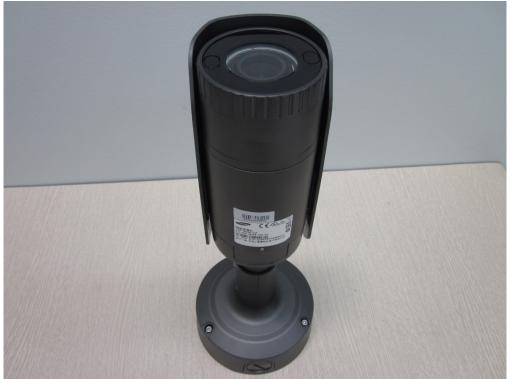
[Front]

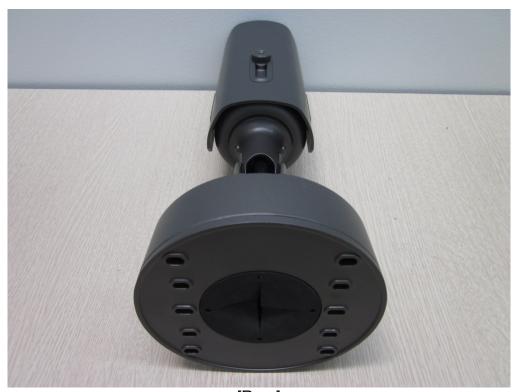
[Rear]

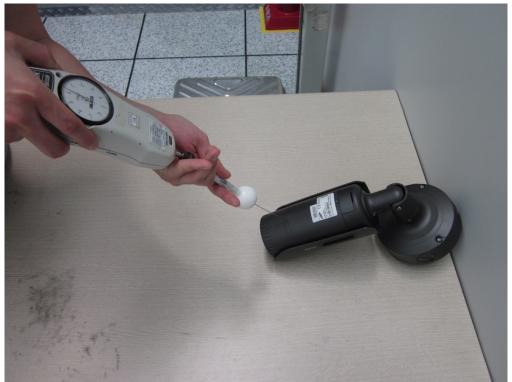
# 3.1.5 TEST Photograph

Item	Description
First characteristic numeral	IP6X (Protected against access to hazardous parts with a wire)
Test condition	<ol> <li>Access probe: 1.0 mm ø, 100 mm length,</li> <li>Test force: 1 N ± 10 %</li> </ol>
Test location	All of the outside openings
Definition	The access probe of 1,0 mm ø shall not penetrate

1) The access probe is pushed against or (in case of the test for first characteristic numeral 2) inserted through any openings of the enclosure with the force specified

[During the test]

Check List	Test Result
Protected against access to hazardous parts with a wire	No abnormal was found

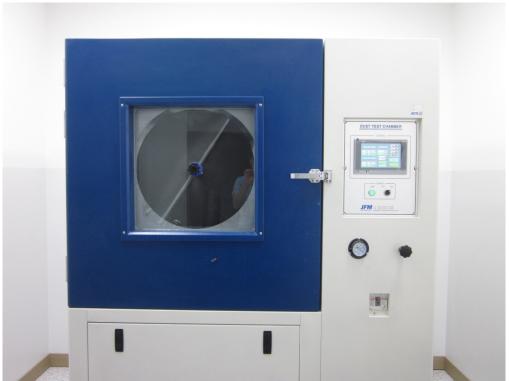
# 3.2.5 TEST Photograph

Item	Description
First characteristic numeral	IP6X (Dust-tight)
Enclosures	Category 1
Test condition	The talcum powder used shall be able to pass through a square-meshed sieve the nominal wire diameter of which is 50 µm and the nominal width of a gap between wires 75 µm. The amount of talcum powder to be used is 2 kg per cubic metre of the test chamber volume
Test time	8 hour
Definition	No ingress of dust

- 1) The enclosure under test is supported inside the test chamber and the pressure inside the enclosure is maintained below the surrounding atmospheric pressure by a vacuum pump
- 2) The suction connection shall be made to a hole specially provided for this test
- 3) The object of the test is to draw into the enclosure, by means of depression, a volume of air 80 times the volume of the sample enclosure tested without exceeding the extraction rate of 60 volumes per hour. In no event shall the depression exceed 2 kPa (20 mbar) on the manometer
- 4) If an extraction rate of 40 to 60 volumes per hour is obtained the duration of the test is 2 h.
- 5) If, with a maximum depression of 2 kPa (20 mbar), the extraction rate is less than 40 volumes per hour, the test is continued until 80 volumes have been drawn through, or a period of 8 h has elapsed.

[During the test]

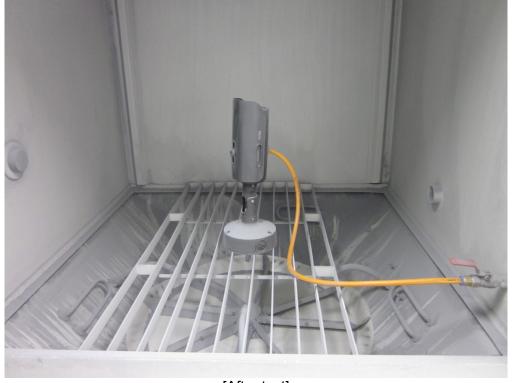
[After test]

Check List	Test Result
Dust-tight	No abnormal was found

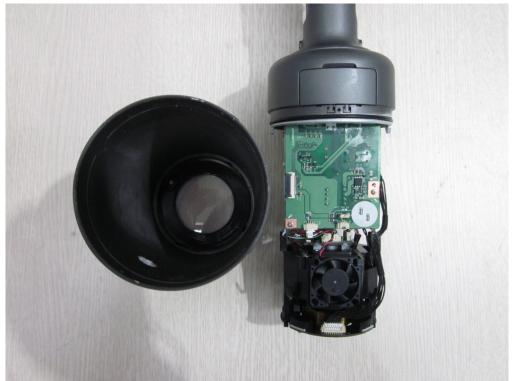
[Test result confirme]

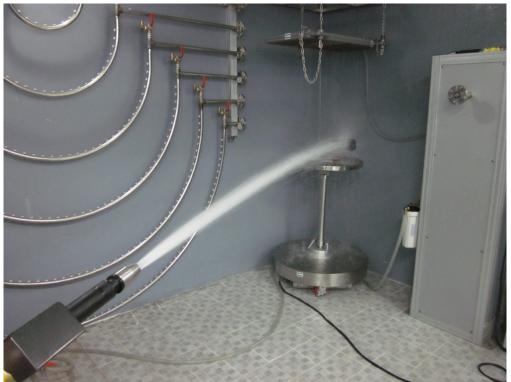
# 3.3.5 TEST Photograph

Item	Description
Second characteristic numeral	IPX6 (Protected against powerful water jets)
Test condition	<ol> <li>Water jet hose nozzle diameter: 12.5 mm</li> <li>Water flow rate: 100 L/min±5%</li> <li>Distance: 2.5~3.0 m</li> </ol>
Test time	1 min/m <sup>2</sup> , at least 3 min
Definition	Water projected in powerful jets against the enclosure from any direction shall have no harmful effects

- 1) The tests are conducted with fresh water
- 2) The water pressure is adjusted to give the specified delivery rate
- 3) The test is made by spraying the enclosure from all practicable directions with a stream of water from a standard test nozzle

[During the test]]

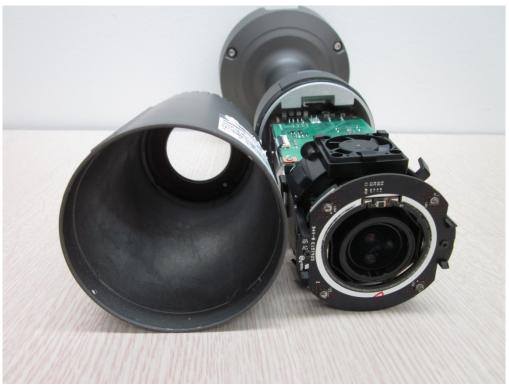
Check List	Test Result
Protected against powerful water jets	No abnormal was found

[Test result confirme]
